**DEPARTMENT OF TRANSPORTATION**

Contract #: 04-0120F4Cty: SF/ALA Rte: 80 PM: 13.2/13.9File #: 69.28**WELDING INSPECTION REPORT****Resident Engineer:**Siegenthaler, Peter**Address:** 333 Burma Road**City:** Oakland, CA 94607**Report No:** WIR-024914**Date Inspected:** 13-Jun-2011**Project Name:** SAS Superstructure**OSM Arrival Time:** 1500**Prime Contractor:** American Bridge/Fluor Enterprises, a JV**OSM Departure Time:** 300**Contractor:** Zhenhua Port Machinery Company, Ltd (ZPMC), Changxing Island **Location:** Shanghai, China**CWI Name:** See Below**CWI Present:** Yes No**Inspected CWI report:** Yes No N/A**Rod Oven in Use:** Yes No N/A**Electrode to specification:** Yes No N/A**Weld Procedures Followed:** Yes No N/A**Qualified Welders:** Yes No N/A**Verified Joint Fit-up:** Yes No N/A**Approved Drawings:** Yes No N/A**Approved WPS:** Yes No N/A**Delayed / Cancelled:** Yes No N/A**Bridge No:** 34-0006**Component:** OBG**Summary of Items Observed:**

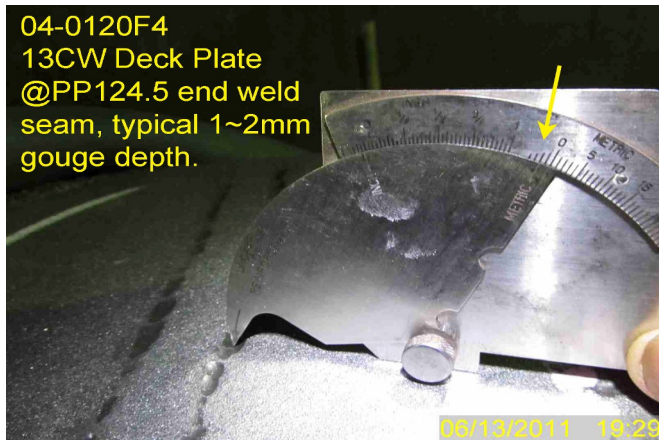
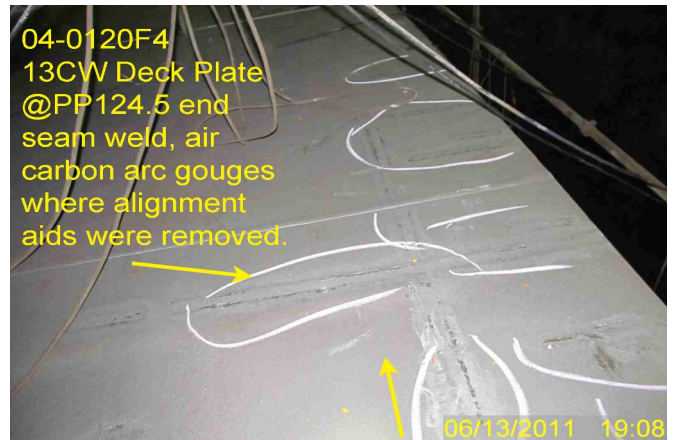
QA performed visual inspection (VT) of exterior welds/surfaces on OBG Segments 13AW, 13BW, 13CW deck plate, Blast Shop 4. The VT inspection location was from the CB side edge plate to deck drip plate at architectural housing side, and end seam weld PP124.5 ~ PP117.5. At conclusion of the QA VT inspection, ABF QC was notified of the inspection results and verified the findings. However, no ZPMC QC present at the time of the post blast inspection. See QUALITY ASSURANCE – POST BLAST WELD REPAIR REPORT, dated 06-13-11 for additional information.

The following digital pictures illustrates deck plate end seam weld near PP124.5 where fit-up alignment aids were removed.
